# BEDALE, AISKEW AND LEEMING BAR BYPASS:

Prospect Archaeology and Pre-Construct Archaeology Ltd have been commissioned by Wills Bros Ltd on behalf of North Yorkshire County Council to undertake a series of archaeological excavations ahead of the construction of the Bedale, Aiskew and Leeming Bar Bypass. The archaeological works were designed by and are being managed by Jacobs on behalf of NYCC.

## The Aiskew Roman Villa

## The Bedale Ditched Enclosure

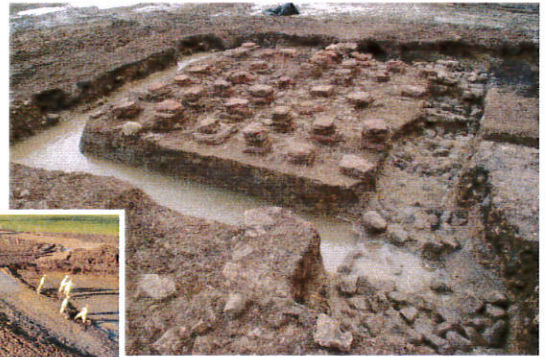
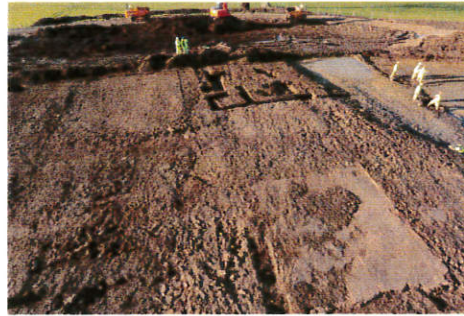
The surviving remains of a heated room of the villa. Stacked columns of tile (pilae stacks) would have supported a suspended floor. Cobble wall foundations survive (right of picture), elsewhere the walls have been removed in antiquity

A small square room with internal dimensions of around 4m was added on to the north-west side of the villa complex at some date; this lay within the road corridor and was fully excavated and recorded. This was a heated room as demonstrated by the remains of pilae stacks which would have supported a suspended floor, forming part of a hypocaust system. Hot air would have been drawn under the floor from a fire within an external stokehole identified on the north-west side of the room. Hollow wall tiles known as box-flue tiles would have been attached to the inside of the stone external walls and the hot air would have travelled up through the tiles and out of the building through vents. The internal surface of the tiles was covered in layers of plaster and the final layer was painted. The demolition debris excavated from this room contained large quantities of these wall tiles and painted wall plaster in many different colours demonstrating that this was a well-appointed room. It may have been used for entertaining and could perhaps have been a heated dining room.

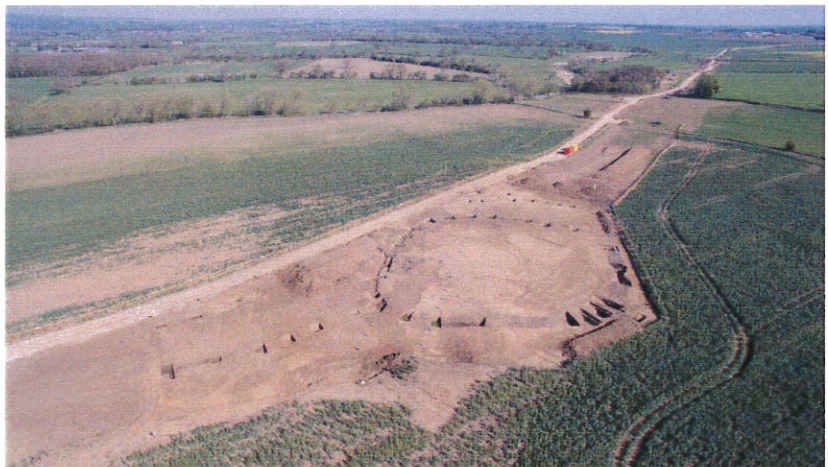
Aerial photograph of the enclosure and ditched trackway after excavation, looking north-east

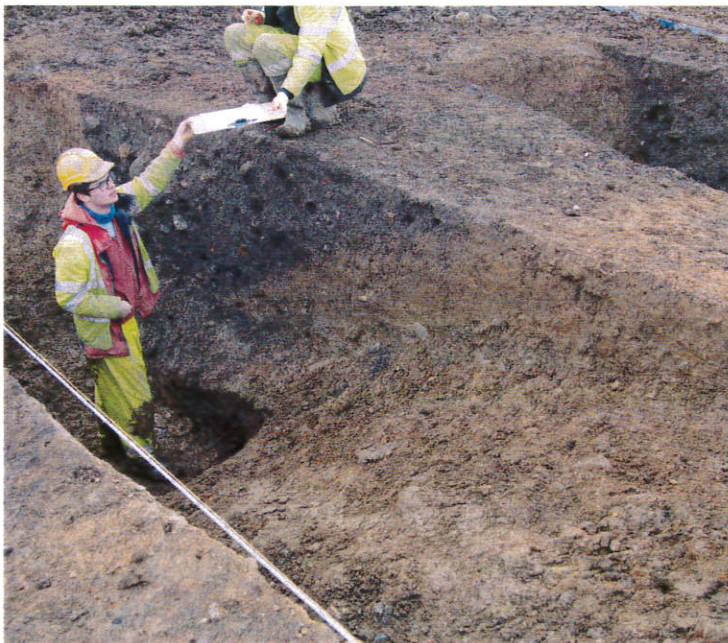
Enclosure ditch during excavation

Excavation has revealed a long sequence of occupation at the enclosure with the earliest phase, a narrow and deep ditch which may have contained a timber palisade, only surviving within the location of a later entrance along the east side of the enclosure. The subsequent phase saw the construction of a massive ditch, up to 6.80m wide and in the region of 2m deep, which silted up and was then recut as a narrower and shallower U-shaped ditch. A narrow entrance provided access on the east side of the enclosure. Two crouched burials were placed within the base of this latest phase of ditch, and following a period of natural silting, the ditch was then infilled during the early Roman period with material which contained large quantities of occupation material.

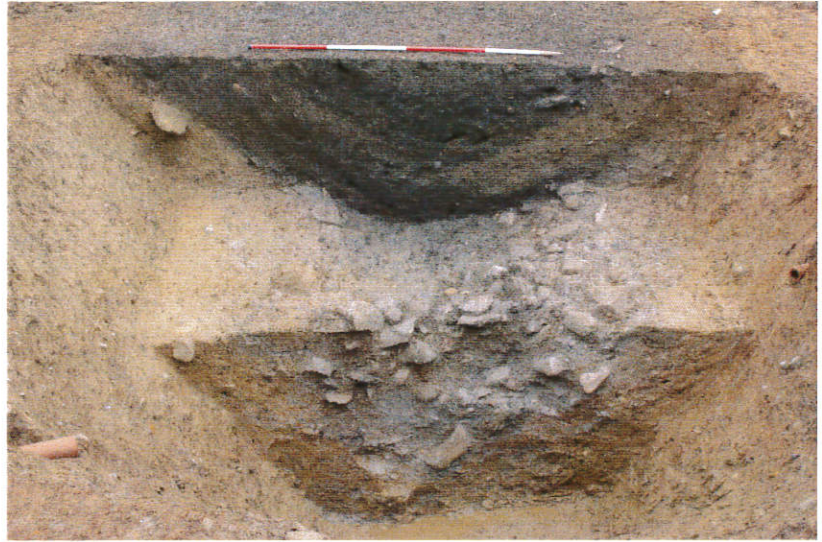
Section through east side of enclosure showing the organic upper fills of the latest recut

The upper fills of the ditch contained large quantities of occupation debris much of which represents waste material from processing and manufacturing activities which presumably took place within the enclosure. A large regionally significant assemblage of animal bones has been recovered from the ditch; the high organic content of the ditch fill has resulted in the excellent preservation of the bone and antler. This includes cattle, sheep, pig and horse along with wild species such as red and roe deer. Bones from very young calves suggest that the settlement was involved in animal husbandry. Small quantities of fish bone and oyster shells attest to long distance trade. As well as evidence for butchery, the animal bone assemblage includes worked fragments and material indicative of waste from craft working. A beautifully preserved antler weaving comb has also been found in the ditch; such tools were used during the Late Iron Age and early Roman periods in textile production and are often decorated such as the Bedale example. Other bone objects include several fragments of serrated rib, a spindle whorl, a long spoon or spatula, a pin and a beautifully decorated handle.

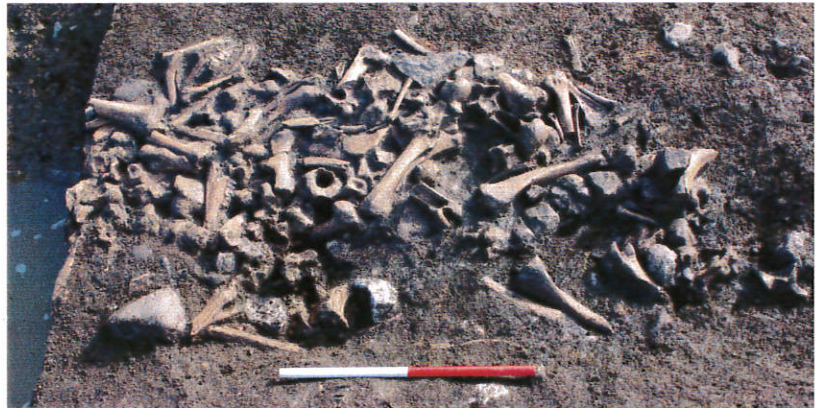
A concentration of animal bone in the upper fill of the ditch
