# BEDALE, AISKEW AND LEEMING BAR BYPASS:

Prospect Archaeology and Pre-Construct Archaeology Ltd have been commissioned by Wills Bros Ltd on behalf of North Yorkshire County Council to undertake a series of archaeological excavations ahead of the construction of the Bedale, Aiskew and Leeming Bar Bypass. The archaeological works were designed by and are being managed by Jacobs on behalf of NYCC.

## The Aiskew Roman Villa

## The Ditched Enclosure (Site 58)

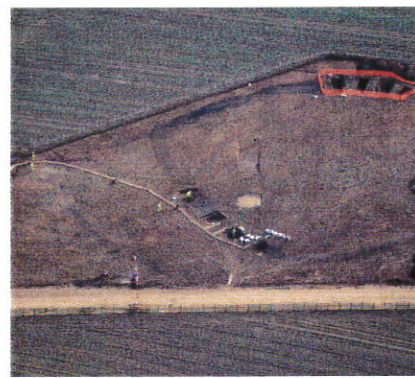
Aerial photograph showing enclosure during excavation, looking south-east

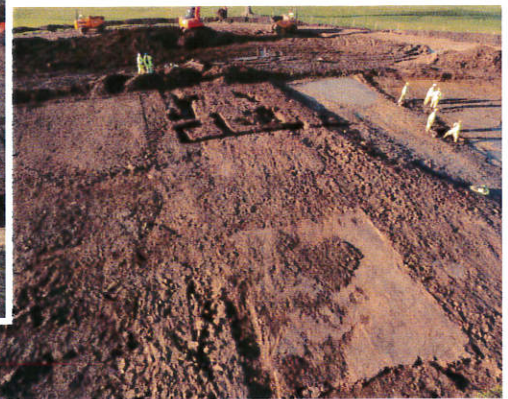
Pre-excavation aerial photograph of villa; room with concrete floor surface in right foreground and earlier evaluation trench in background (looking west)

Within the area stripped, a range of rooms are located on the east side of a 4m-wide north-south aligned corridor within which small areas of tessellated surface survive. An intact concrete floor surface survives in the room at the north-east end of the corridor and on top of this were areas of painted wall plaster which had collapsed onto the floor, possibly when the villa was demolished.

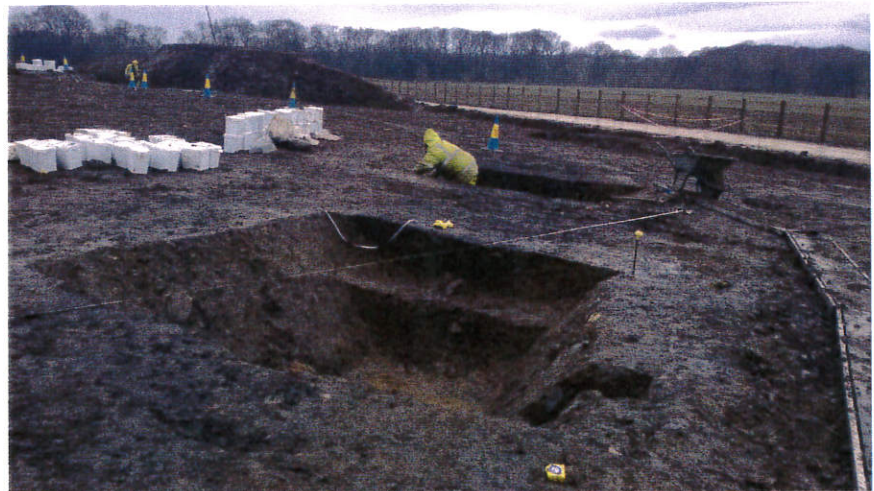
Excavation of the enclosure ditch
